# Final Report

## Crime Prevention through Environmental Design (CPTED) for Public Transit Stations

**Jennie Perey Saxe, Ph.D.**

University of Delaware

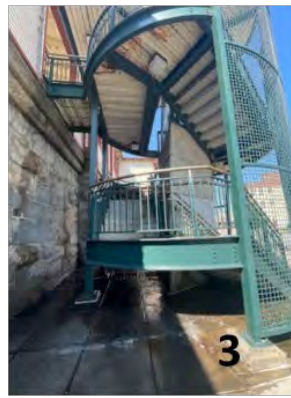
1. Site G gated tunnel to prevent unauthorized access.
2. Site G interior; this side of the stairway and column are not visible directly from the operator booth (background); an installed mirror provides some visibility; also visible is bright paint and lighting.

3. Site G exterior stairway to southbound platform with maintenance need; lighting adequacy not assessed; some hiding spots due to the central shaft of the stairway.

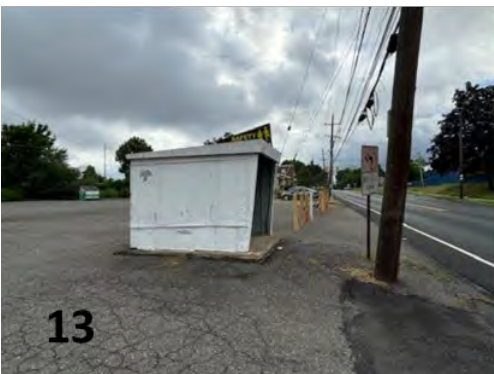
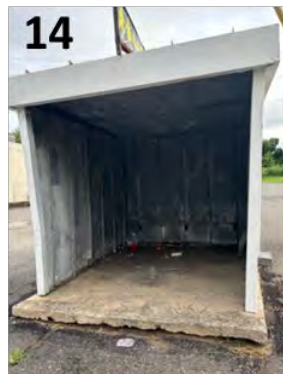
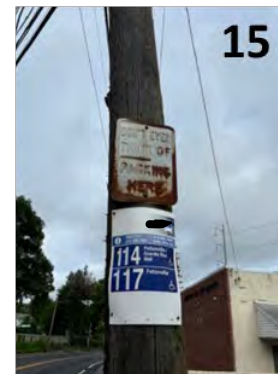
13. Site J: visible are shelter with poor visibility, peeling paint, and rusting roof located in a large parking lot; bollards present but may not be sufficient to prevent vehicle ramming.

14. Site J interior with litter; not shown: rusting roof.
15. Site J signage to deter unauthorized parking.; Transit Agency 2 signage faded, but hotline is visible.

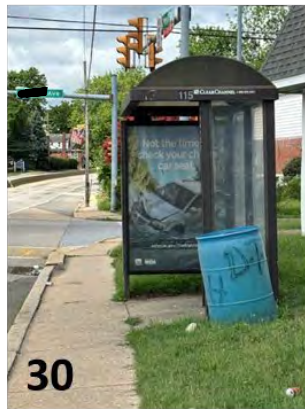
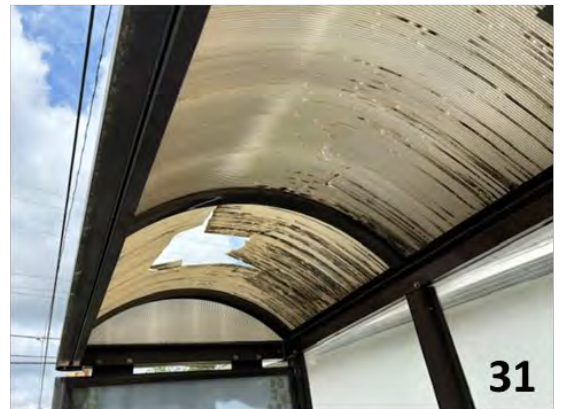
30. Site M bus shelter includes waste bin, but litter is present; no Transit Agency 2 signage was present other than the route number and another number which was not the stop ID on the shelter itself; ad on end of shelter blocks visibility.
31. Site M shelter roof is made from translucent material, providing some natural light, but has significant damage.
